## **HORIZONTAL SPLIT-WEB FRACTURES OF FLASH BUTT WELDED RAILS**

**Hassan FARHANGI and Seyed Mostafa MOUSAVIZADEH**

School of Metallurgy and Materials Engineering, Faculty of Engineering, University of Tehran, Tehran, Iran.

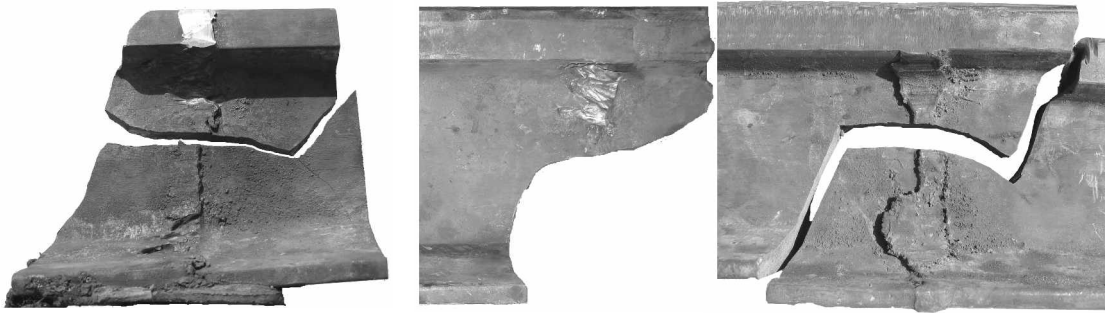
The three fractured flash welded rail which exhibit similar fracture features are shown in Figure 3. The nearly horizontal fracture plane passing through the flash weld fracture and macroscopic direction of crack propagation which is determined with the help of chevron marks on the fracture surface are shown in Figure 4. The crack propagates parallel to the rail surface (horizontally) in the vicinity of the rail web and then branches toward rail head and base at the angle of about of 45°.

**Figure 3.** Fractured flash welded rail

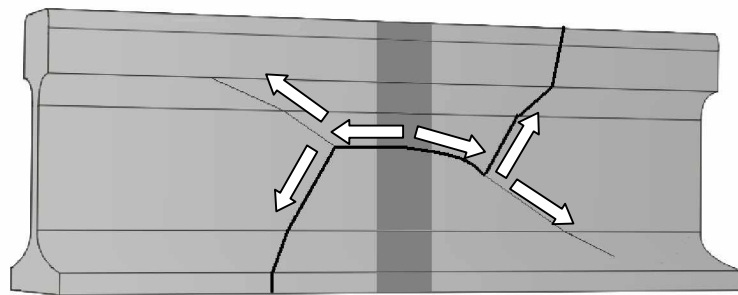
**Figure 4.** Macroscopic crack propagation direction.

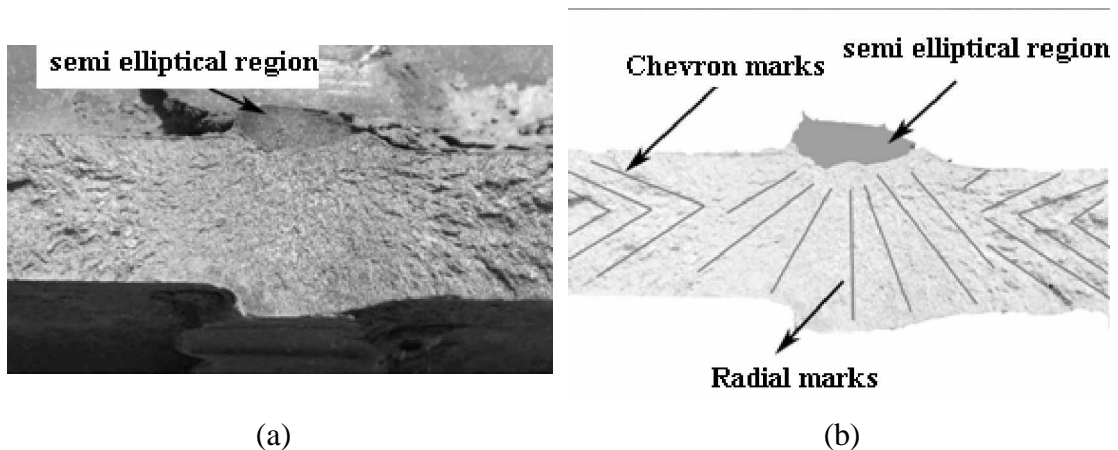
As shown in Figure 5 (a,b) a small semi elliptical region can be seen in the fracture surface of the horizontally crack with a clearly defined demarcation. This region which exhibits a smooth appearance has been exactly located near the expelled materials during upsetting (upset materials). Radial and chevron marks are observed in the relatively rougher region outside of the semi elliptical region. The two macroscopically distinct regions of the fracture surface are more clearly shown in a schematic drawing in Figure 5(b).

**Figure 5.** (a) Macroscopic fracture surface appearance and (b) schematic of distinct regions and fracture surface markings of a horizontal split-web fracture.

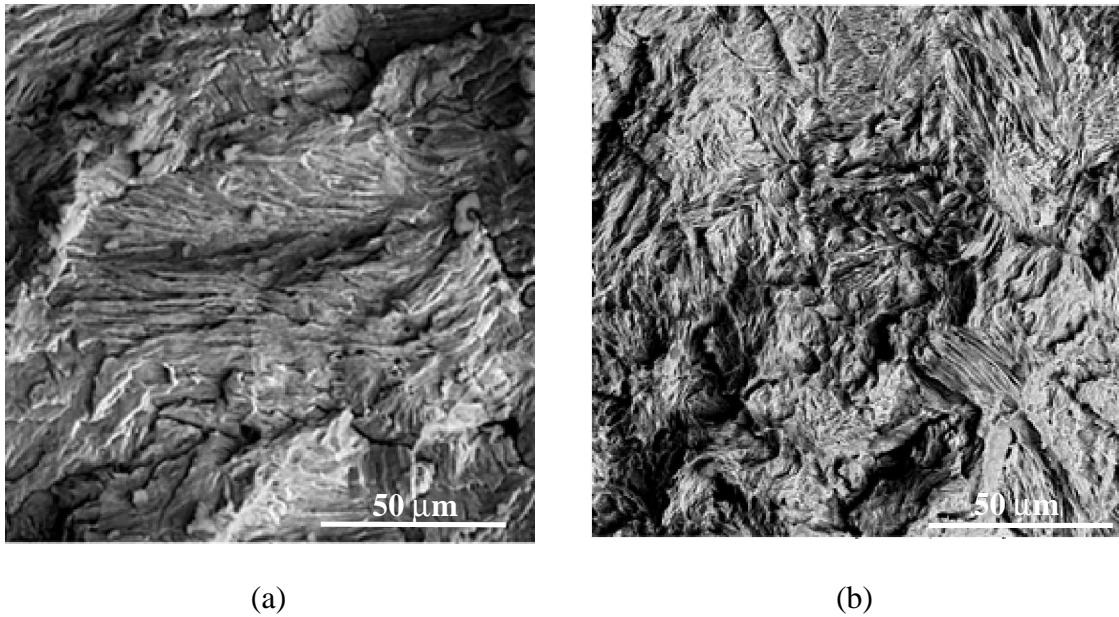
Fracture surface of semi elliptical region consisted of complex surface topography. Examination of fracture surfaces by SEM at higher magnifications (Figure 6) reveals adjacent regions with differently oriented parallel markings which are indicative of extensive

microstructural influence on the microscopic crack growth direction during slow and stable crack growth. Microstructural examinations indicate that this type of fracture morphology is closely related to the layered structure of pearlit, which consists of ferrite and cementite.

**Figure 6.** Complex surface morphology of the semi elliptical region.

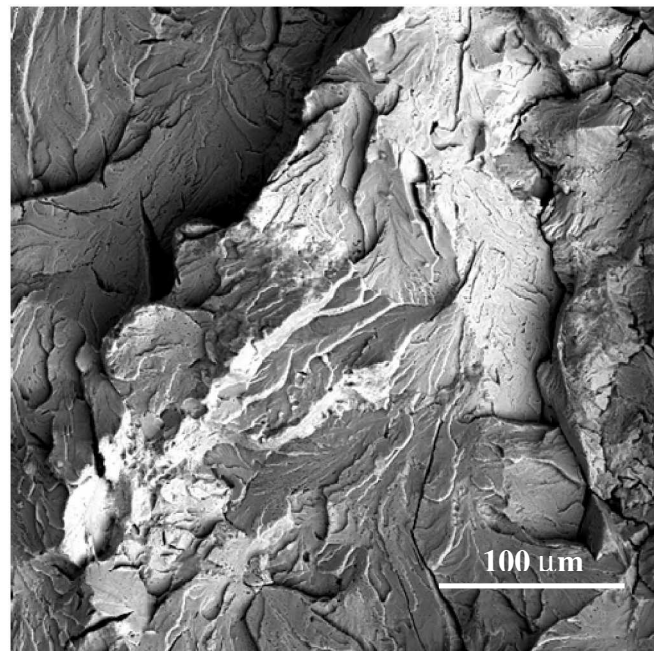
The fracture surface exhibits a clear change in fracture mechanism outside the semi elliptical region. The dominant fracture morphology changes to that of fan-shaped cleavage facets characteristic of a low energy brittle fracture process (Figure 7). Consequently, the boundary of the semi elliptical region clearly demarcates the position of the crack front at the onset of transition from slow stable cyclic crack growth to fast unstable final fracture.

**Figure 7.** Fan-shaped cleavage facets outside the semi elliptical region.

Based on the above macroscopic and microscopic observations cyclic crack growth due to fatigue can be identified as the main contributing factor to the failure of flash welded rails. The small size of the semi elliptical crack at the onset of unstable fracture is indicative of the low fracture toughness of the rail steel, which is reported to be about  $30 \text{ MPa}\cdot\text{m}^{1/2}$  [8], and the high stress levels.

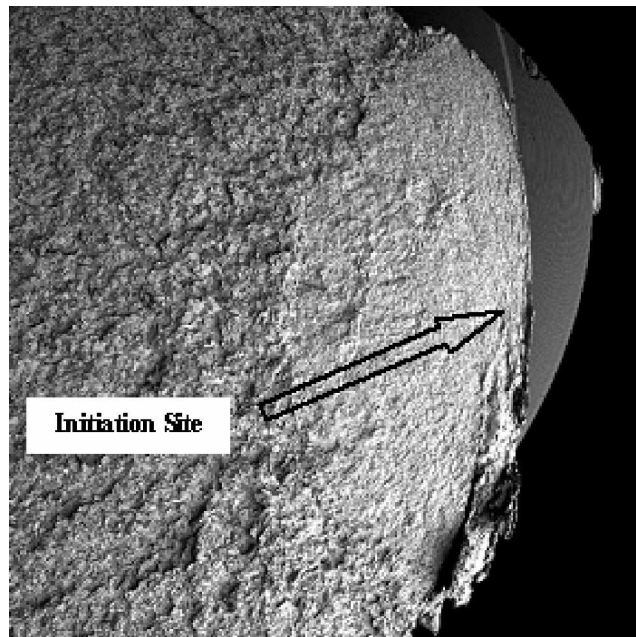
A low magnification SEM fractograph of the Semi elliptical fatigue region is shown in Figure 8. Beach marks and ratchet lines are observed on the fatigue fracture surface which trace back to the crack initiation site associated with the upset material on the weld joint at the rail surface. EDS analysis of the fracture surface at the initiation site shown in Figure 9 reveals the presence of oxides in this region.

**Figure 8.** Low magnification SEM fractograph of the Semi elliptical fatigue region.

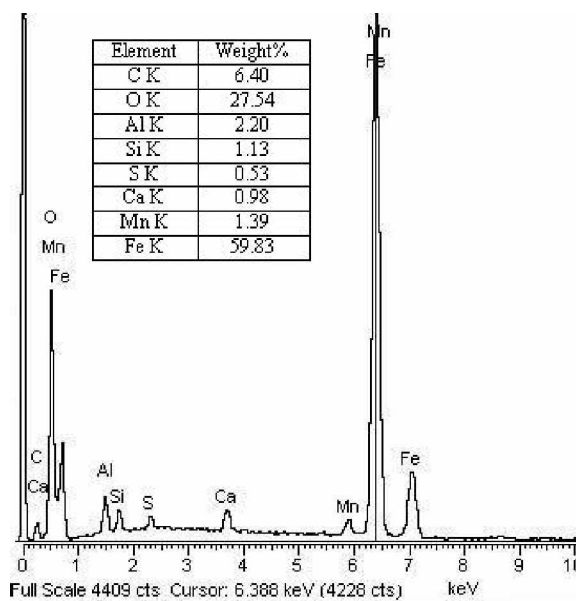
**Figure 9.** EDS analysis of the fracture surface at the initiation site.

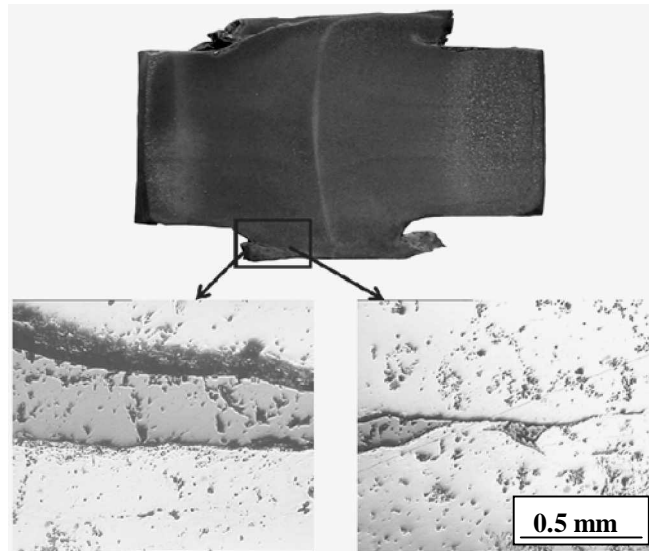
Presence of oxide impurities is confirmed by microstructural study of metallographic sections directly beneath the fracture surface. Large oxide inclusions, which were trapped during removal of upset material by the hydraulic shearing device at the end of the welding process, can be clearly seen in Figure 10. In addition, cast structures and decarburized materials can be seen at the weld surface. Porous and particulate materials that have not been compacted during the upsetting are also observed. Microstructural study of the section perpendicular to the fatigue crack reveals the weld surface is highly porous and contains entrapped oxides penetrating up to a depth of 3 mm beneath the surface. These defects produce a very inferior quality weld surface which facilitates and accelerates nucleation of fatigue cracks.

**Figure 10.** Large oxide inclusions trapped during removal of upset material.

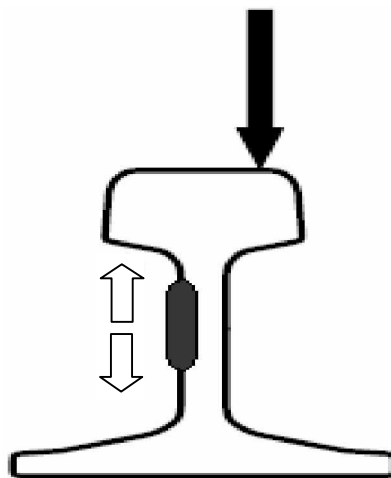
Cyclic tensile stresses perpendicular to fatigue crack surface are prerequisite for observed fatigue crack propagation. Indeed stress components of tensile character must develop near the web region of the rail in the vertical direction. It can be seen from Figure 11 that the tensile stress component can develop due to eccentric vertical load of the wheel passing over the rail.

**Figure 11.** Development of tensile stresses in the web due to Eccentric vertical load of the wheel.

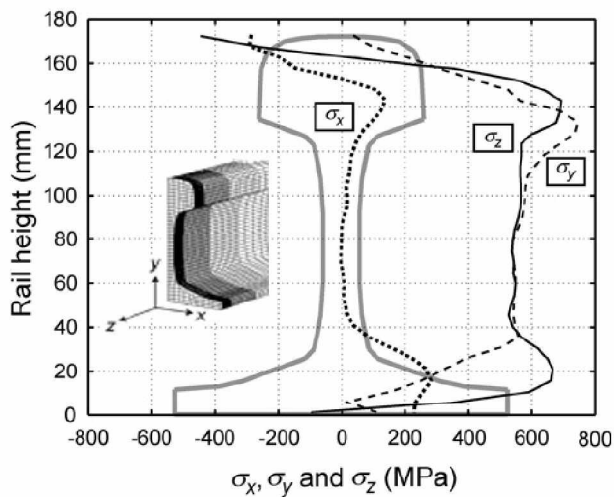
High tensile residual stress can be developed as a result of the thermal cycle of flash butt welding process. In the rail web of the weld region, both vertical and longitudinal components of the residual stress field are strongly tensile. Vertical tensile residual stress in the web's middle of the weld region has been reported by some researcher. Skyttebol et al. [3] showed through modeling and experimental measurements that vertical tensile residual stress in the web's middle of the weld region is about 500 MPa (Figure 12). Smaller compressive or tensile stresses that can be produced during wheel passing over the rail are superimposed on residual tensile stresses and therefore inferior tensile-tensile cyclic stresses are developed. More inferior cyclic stresses are produced when torsional loading is increased; for example when the vertical load is applied near the field side of the rail and/or the lateral wheel loading is increased due to the curves or vehicle hunting. These cyclic stresses are not developed in the rail because the residual stress in the rail is quite different from the weld region and hence these types of fractures are not observed in the non-weld regions.

**Figure 12.** Vertical tensile residual stress the weld region ( $\sigma_y$ ) [3]
