AN INVESTIGATION ON FAILURE ANALYSIS OF TITANIUM GAS TURBINE COMPRESSOR BLADES

ABSTRACT

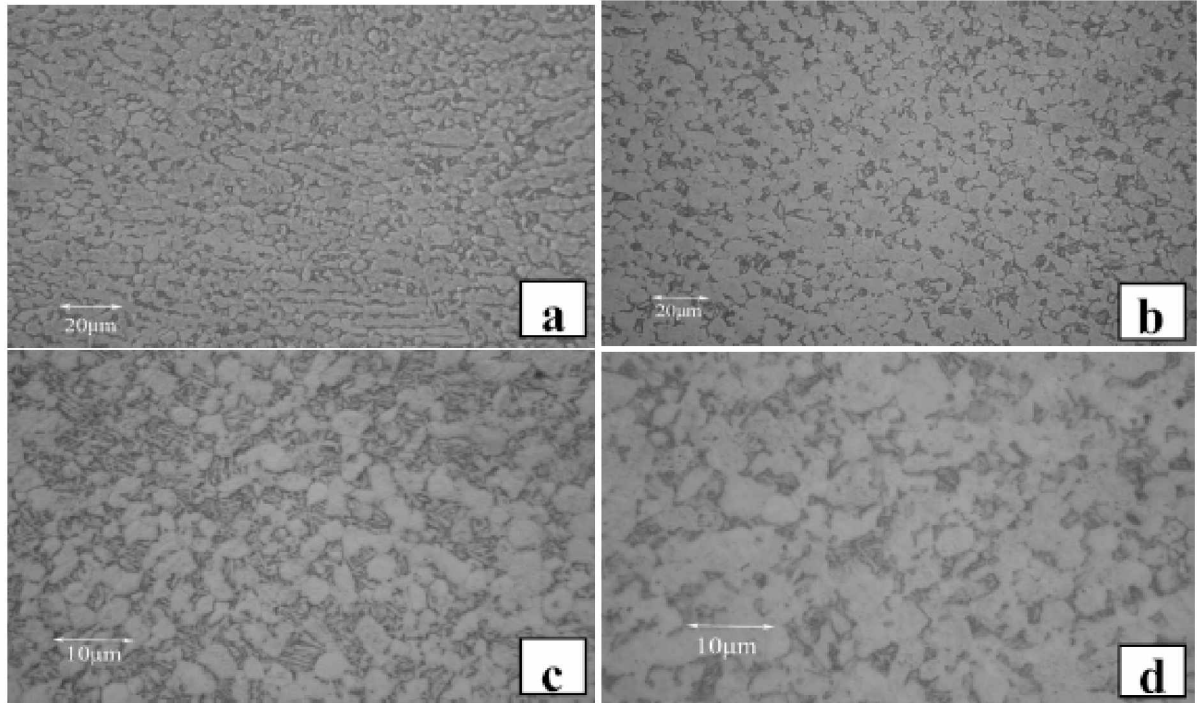
Table 2 shows chemical composition of the blade material compared with the standard limits of Ti6Al4V alloy. It confirms the composition of the fractured blade to be Ti6Al4V alloy. The microstructures of the blade root and airfoil with different working hours are presented in Figure 1. It is consisted of predominantly equiaxed α grains, lamellar transformed α plates, and fine intergranular β phases with the percents of 65% and 35%, respectively. It should be noticed that this microstructure is common in Ti-alloy compressor and fan blades, with equiaxed portion providing good tensile ductility and hence good resistance to crack initiation, while the lamellar portion is responsible for increasing resistance to crack propagation.

Figure 1. Microstructure of the fractured blades: a,b) root & c,d) airfoil; a,c)1st & b,d) 2nd fractures.

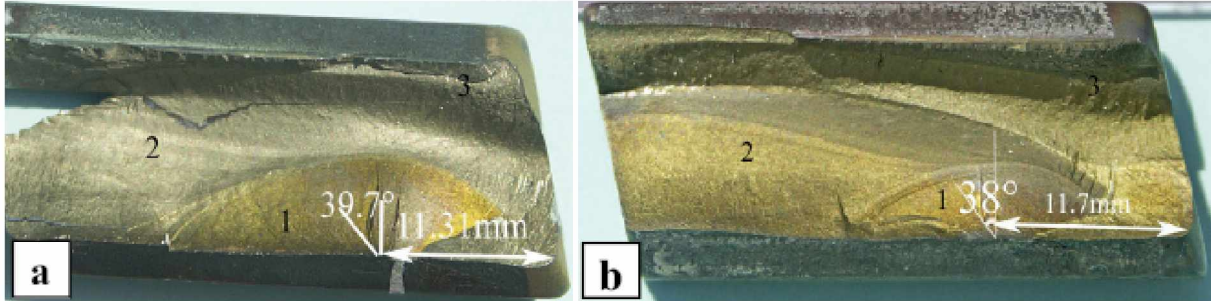
Figure 2. Fracture surfaces of the: a) 1st and b) 2nd failure. Note that three distinct regions are numbered and the main position for crack initiation are identified by an angle.

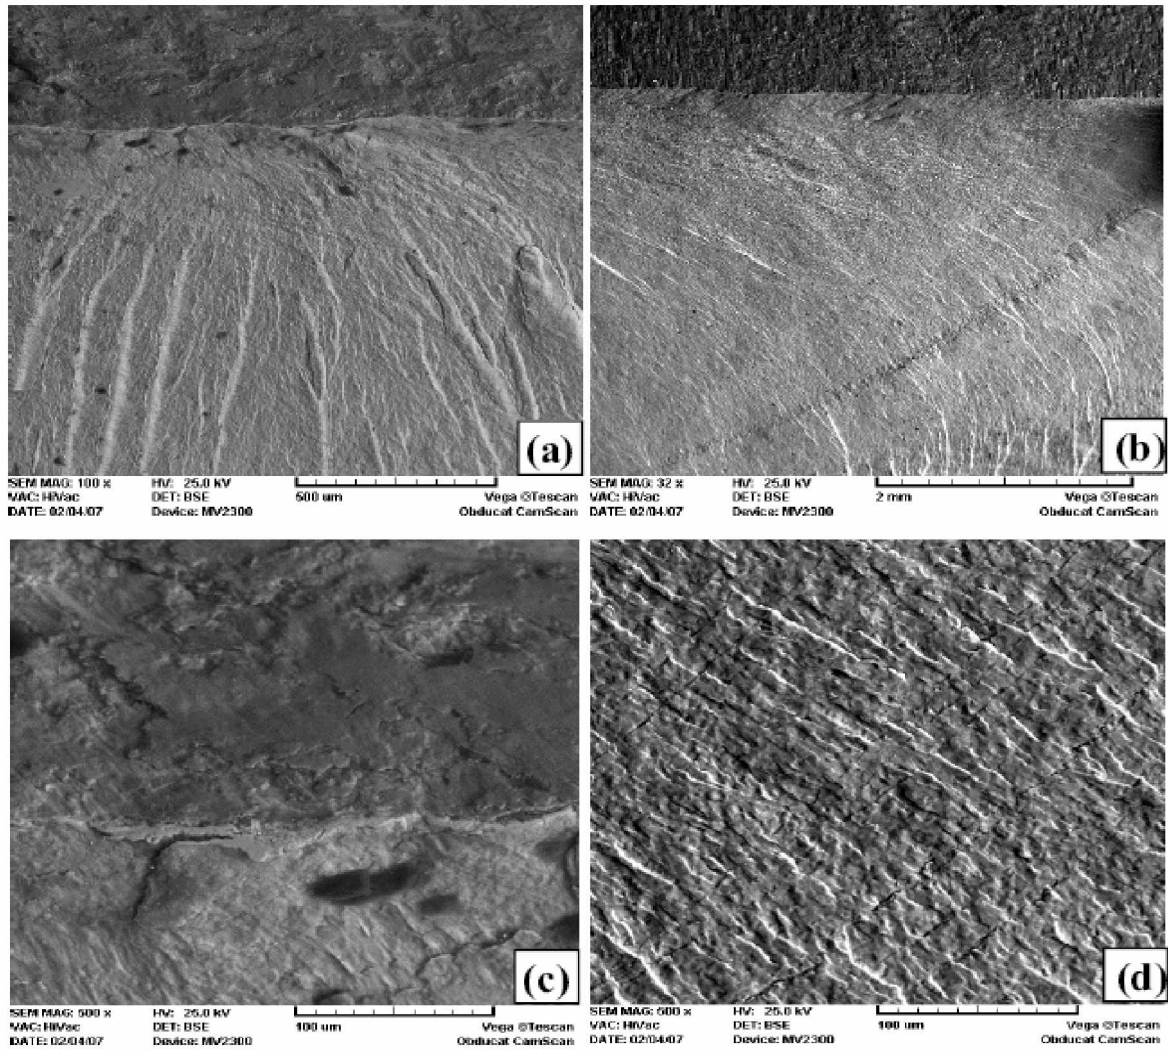
Micro-fractography tests were performed on different fracture surfaces as shown in Figure 3 for the 1st fracture. Figure 3a shows the main crack, beach marks and radial lines in region 1 of fracture surface. Figure 3b illustrates the fatigue appearance in region 2. The image of EOC and multiple micro crack initiation are observed in Figure 3c. The brittle fracture mode can be clearly seen in the fracture surface as shown in Figure 3d. Many debris particles as an indication of wear were found on EOC and in the mouth of cracks (Figure 4). EDS analysis (Table 5) of the debris particles showed a high amount of oxygen confirming oxidation of Ti during the service, which is responsible to form abrasive TiO₂ particles in the fracture surface.

Figure 3. Micro-fractography of the 1st fracture surface: a) region 1, b) transition to region 2, c) EOC, and d) brittle manner of material.

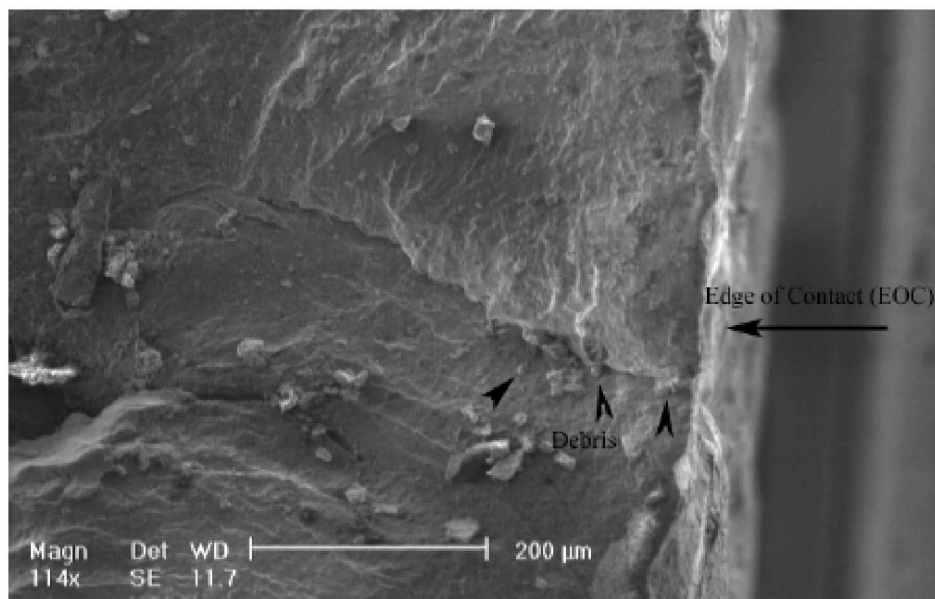
Figure 4. Micro-fractography of the 1st cracked blade fracture surface showing the main crack and debris in mouth of crack.

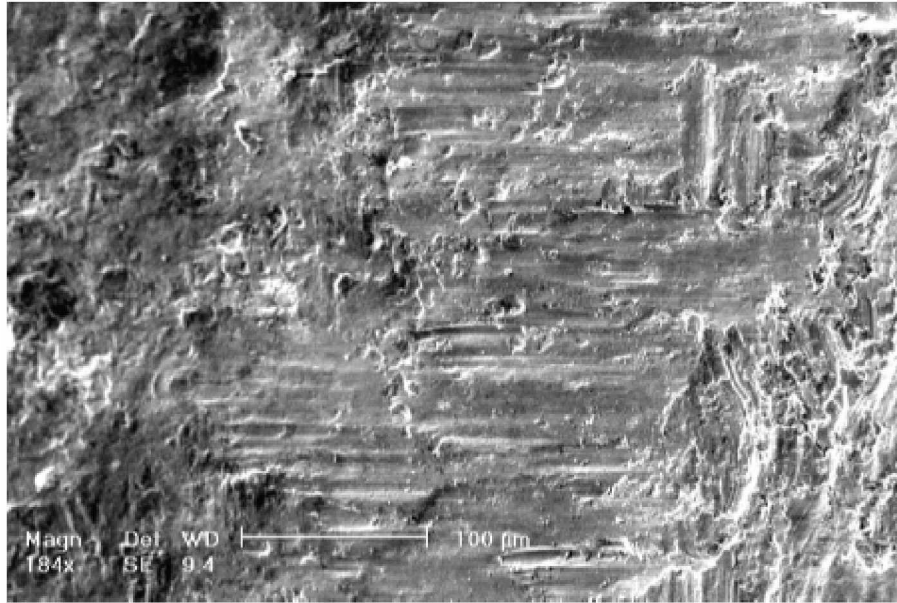
Debris also showed some iron content coming from the steel disk. Severe sliding and rough surfaces were observed in EOC in the blade roots as shown in Figure 5. It is believed that the coating of blade root and disk in the contact region were damaged making these surfaces so rough which can directly influence the crack initiation. The results of roughness measurements are listed in Table 6. As it can be seen, the maximum surface roughness is achieved in the EOC region.

Figure 7. Micro-fractography of the 2nd fracturesurface showing sliding marks on EOC.
