# **FRACTOGRAPHIC AND MICROSTRUCTURAL INVESTIGATION OF THE FAILURE OF HIGH TEMPERATURE NIMONIC 80A INSERT BOLTS**

**Hassan FARHANGI and Peyman SAMIMI**

School of Metallurgy and Materials Engineering, Faculty of Engineering,  
University of Tehran, Tehran, Iran.

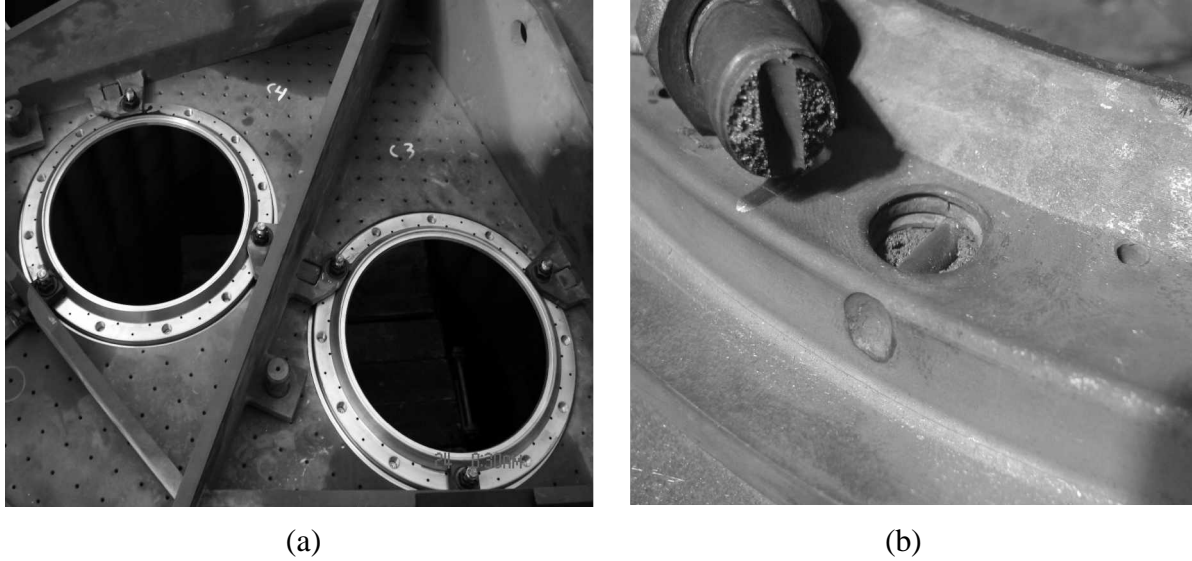
The present paper reports the investigation of the failure of Nimonic 80A insert bolts, which connect the air duct rings to the combustion chamber ceiling. The 159 MW capacity unit had a history of about 36000 h of safe operation prior to the accident. During normal service operation and without any prior indications a broken fragment of the bolts dropped into the combustion chamber and entered the turbine section from a small design opening, causing extensive damage to the turbine blades. The unit was then automatically shut down due to excessive vibrations. In preliminary examinations it was found that all three insert bolts of one of the rings in the combustion chamber ceiling were broken. In an attempt to retrieve the remaining insert bolts from other rings on the ceiling for further investigations, many of the insert bolts broke with the slightest applied torques during loosening.

**Figure 1.** The combustion chamber rings (a) and a broken insert bolt (b).

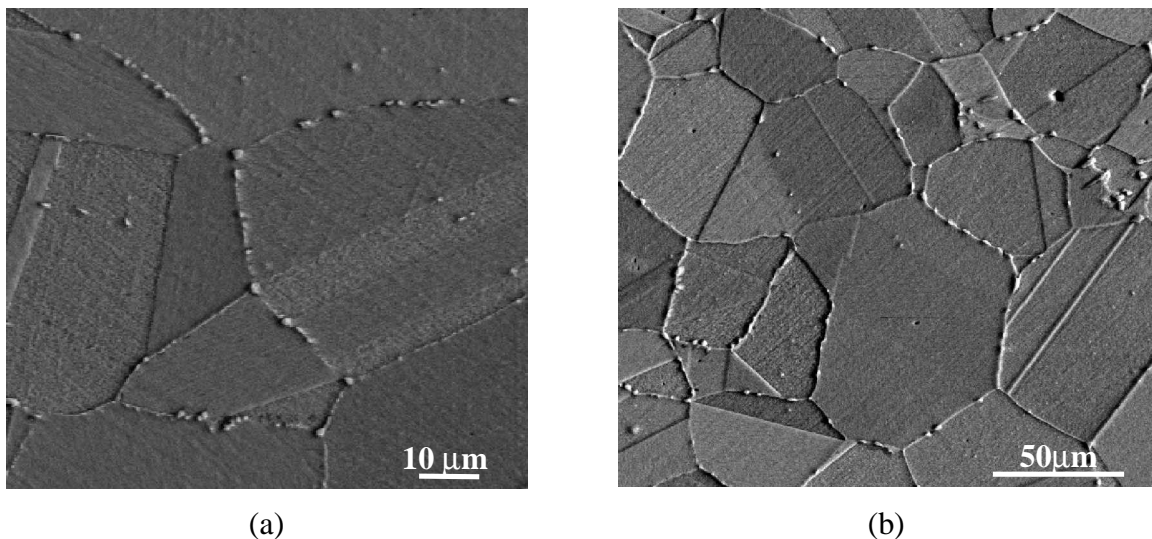
Representative SEM micrographs showing the microstructure of a new and unused bolt are shown in Figure 2(a,b). It can be seen that the microstructure mainly consists of equiaxed grains, twins, and a broad distribution of relatively coarse, distinct and globular grain boundary carbides, which are mainly the chromium rich  $Cr_7C_3$  type carbide [1,3], as well as some carbides within the grains.

**Figure 2.** SEM micrographs of a new insert bolt at low (a) and high magnifications (b).

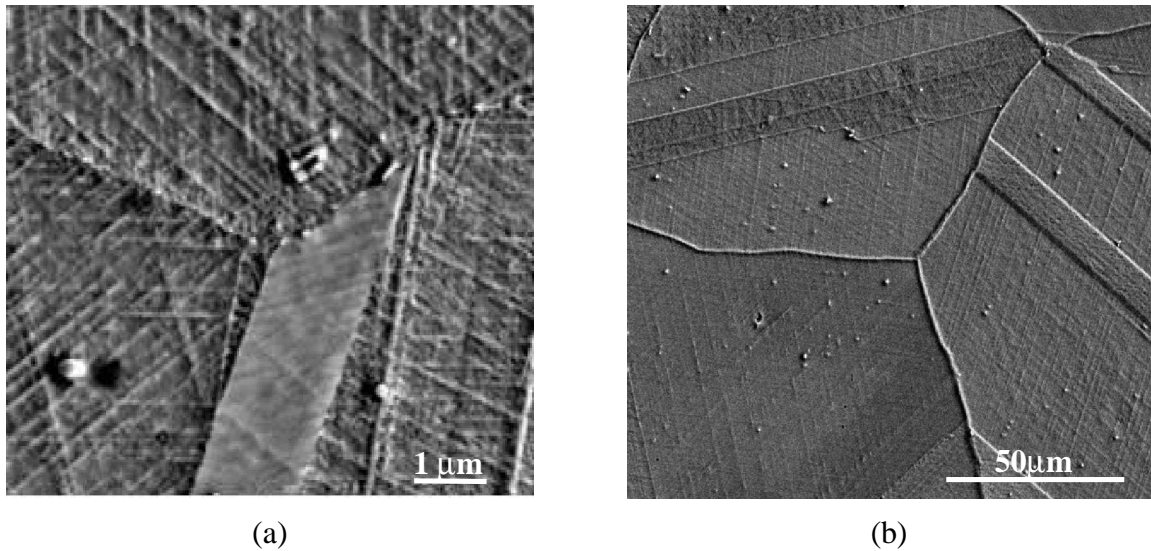
The microstructures of broken insert bolts are also shown in Figure 3(a,b). Extensive precipitation of carbides on slip planes and formation of a more or less continuous grain boundary carbide layer are among the main microstructural features which can be identified in the broken bolts. The main carbides which precipitate during long time exposure at service temperatures of Nimonic 80A bolt material are  $Cr_{23}C_6$  type carbides [1,3].

Furthermore, careful examinations of the microstructures of broken insert bolts in Figure 3(a,b) and other regions also reveal that distinct grain boundary carbides are not present. Distribution and morphology of grain boundary carbides is considered to have a pronounced effect on the mechanical properties and fracture behavior of Nimonic 80A superalloy [1,3-5]. A continuous film of carbides along grain boundaries provides a continuous fracture path and is therefore detrimental to the impact properties. Also it restricts grain boundary sliding during creep and leads to excessive stress concentration and early fracture [1,3-6].

**Figure 3.** SEM micrographs of broken insert bolts at low (a) and high magnifications (b).

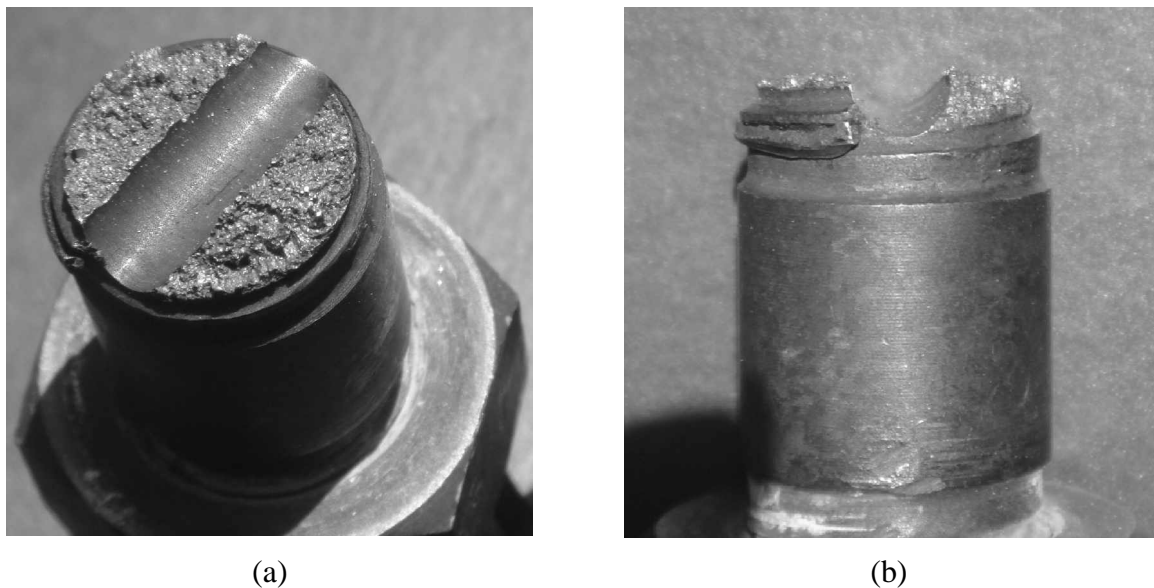
Figure 4(a,b) show the fracture surface of one of the main broken insert bolts. The fracture location of the bolts is at the roots of the first or second thread, which carry the highest loads [7]. The general orientation of the fracture surface is roughly perpendicular to the bolt axis. This fracture location and orientation coincides with that of other insert bolts which broke during loosening in preliminary inspections after the accident.

**Figure 4.** Fracture surface of a failed bolt, (a) top view and (b) side view (2×).

A pin hole which is designed to keep the bolts tight and prevent its loosening during service can be seen at the middle of the fracture surface crossing through the bolt. Macroscopic appearance of the fractured bolts indicates that the fracture process occurred without any measurable change in the cross sectional area or plastic deformation. Accordingly, the fracture process of the insert bolts can be categorized as a macroscopically brittle fracture process [8]. Furthermore, the fracture surface appears to be relatively rough. Fractographic observations using SEM revealed that this rough appearance is associated with cracking along grain boundaries rendering a three dimensional topography to the fracture surface as shown in Figure 5(a-c). Formations of wedge shaped cracks due to relative sliding of adjacent grains as well as widespread secondary intergranular cracking are among the main microfractographic features of the fracture surface.

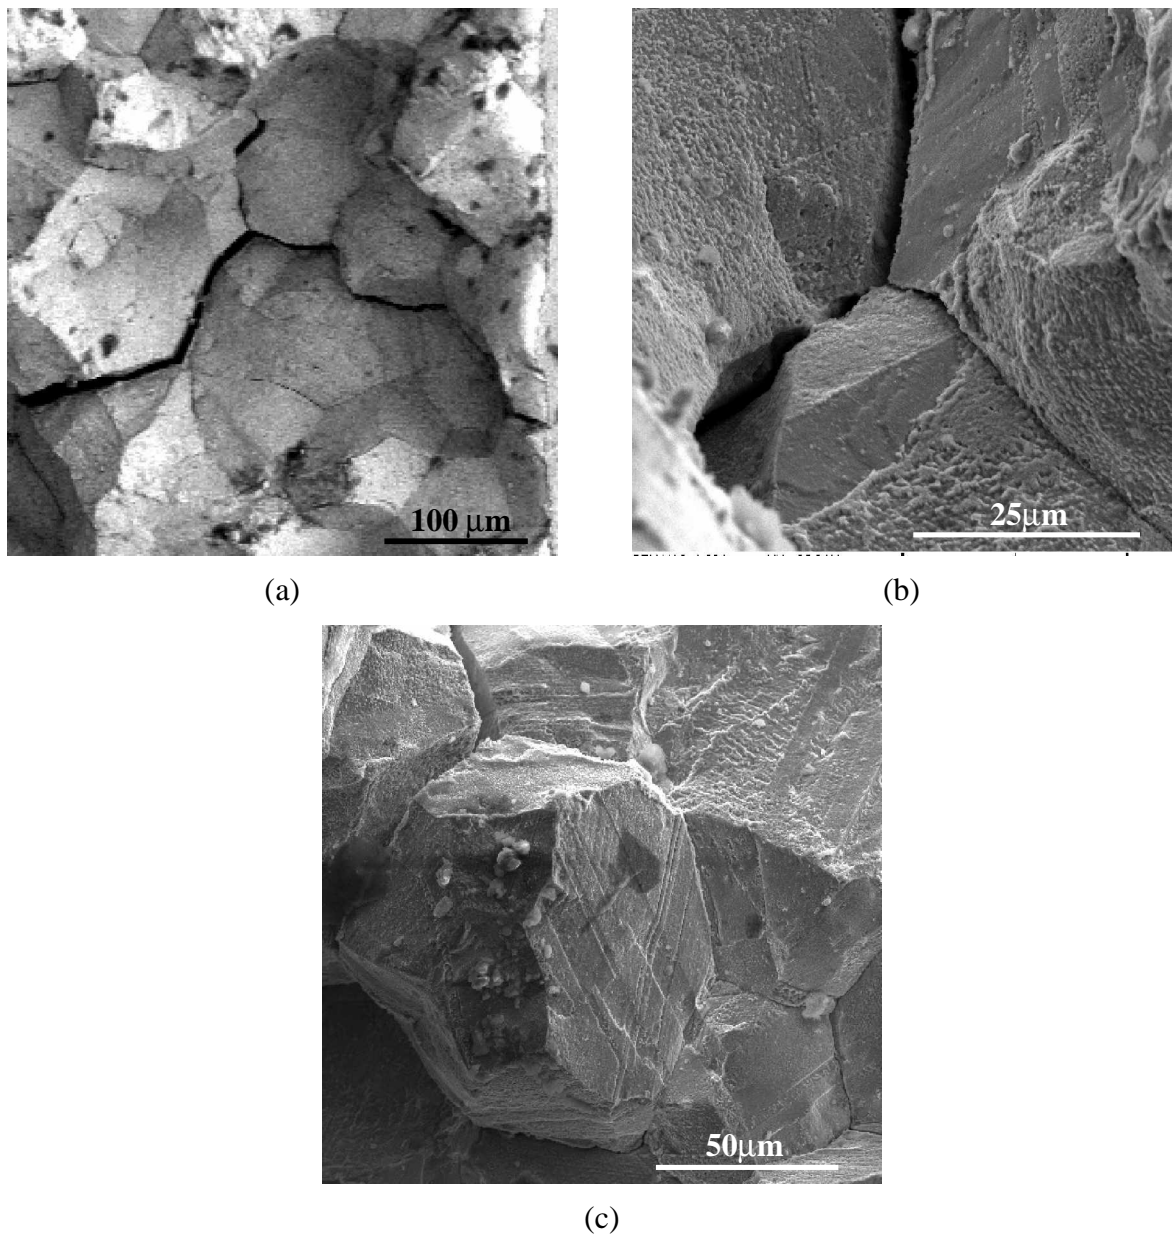
**Figure 5.** SEM Fractographs showing (a) Intergranular fracture surface of a failed insert bolt, (b) Wedge type cracks, and (c) separation of a grain along most of its boundaries.

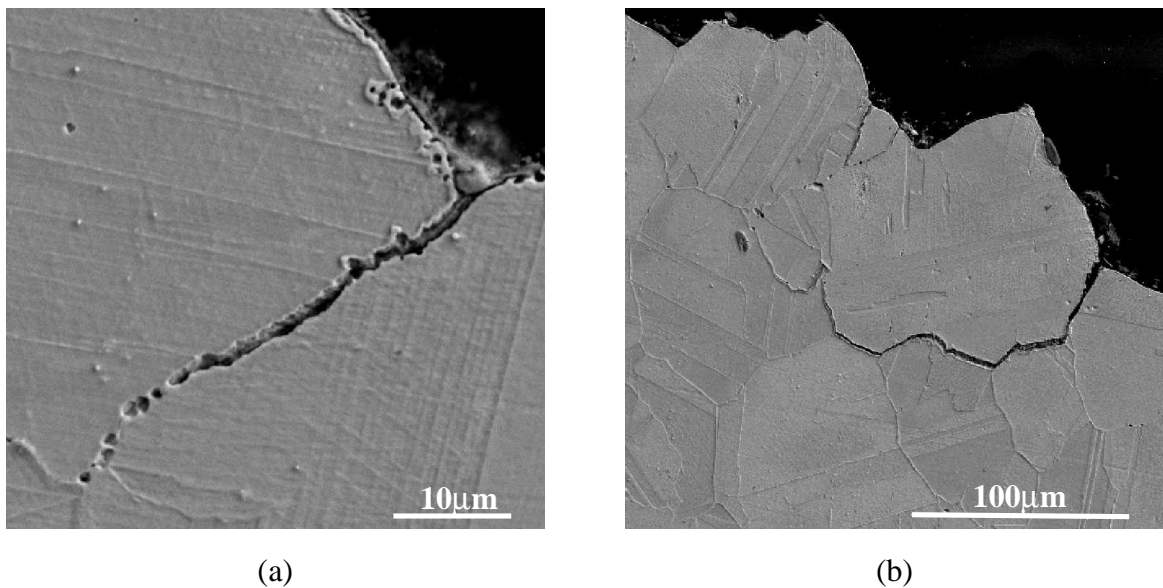
In order to further elucidate the relationship between the microstructure and fracture mechanism of the insert bolts, metallographic sections were cut at a 90 degree angle to the fracture surface and prepared for SEM observation. Significant advance of secondary cracks along the grain boundaries and a row of cavities extending downward from a triple point on the main fracture surface can be seen in Figure 6(a,b). In addition, close examination of the microstructure in this region also shows that particulate type grain boundary carbides are nonexistent or have a very limited distribution at best; instead a network of carbide layers is observed which delineates the grain boundaries in this region. The above findings show that intergranular creep fracture by wedge type cracking due to grain boundary sliding [6,8,9] was the main mechanism involved in the fracture of insert bolts.

**Figure 6.** SEM micrographs showing (a) secondary crack advance beneath the fracture surface of a failed insert bolt and (b) a row of cavities extending downward from a triple point.
