FRACTOGRAPHIC INVESTIGATION OF THE FAILURE OF SECOND STAGE GAS TURBINE BLADES

Hassan FARHANGI and Ali Asghar FOULADI MOGHADAM

School of Metallurgy and Materials Engineering, Faculty of Engineering,
University of Tehran, Tehran, Iran.

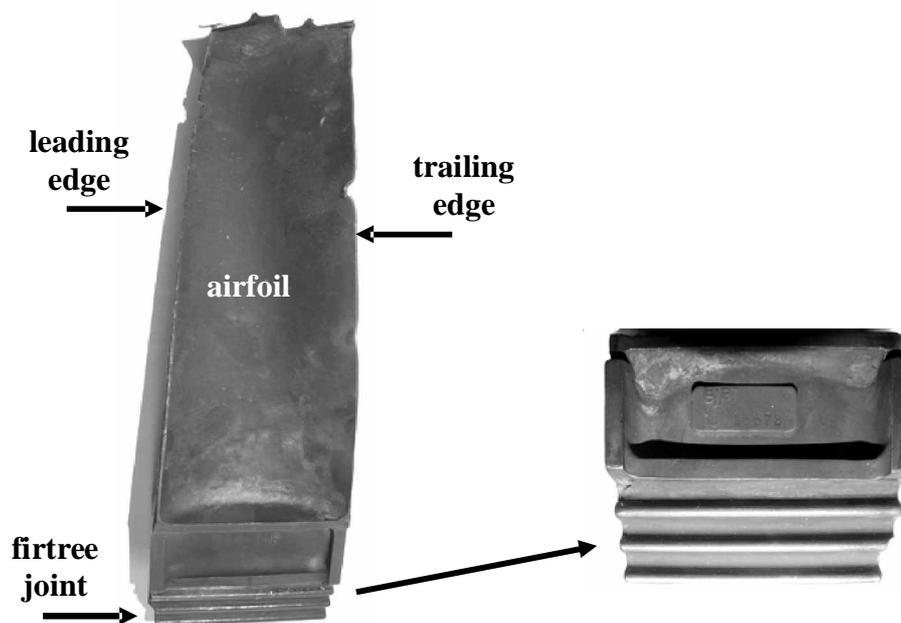
A damaged turbine blade which was retrieved from the accident site is shown in Figure 1. The firtree joint is also separately presented in the above mentioned figure. The remaining portion of the main fractured turbine blade under investigation which only includes the firtree root region, due to complete separation of the air foil section of the blade in the fracture process, is shown in Figure 2.

Figure 1. Blade geometry and the firtree joint of a damaged turbine blade.

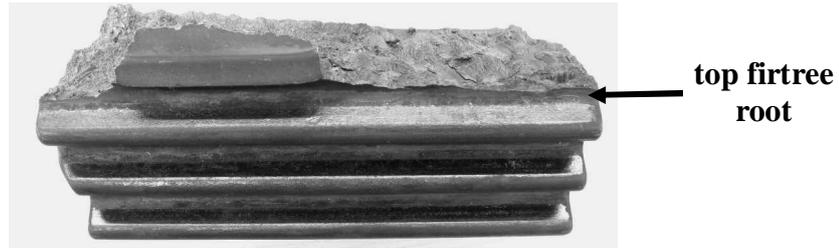
Figure 2. The remaining firtree root region of the fractured blade.

The side view of the fractured blade presented in Figure 2 shows that the failure surface is located at the top fir tree root. The general orientation of the fracture surface is nearly normal to the longitudinal axis of the blade. Visual examination of the fractured blade indicates that the fracture process involved minimal gross plastic deformation with no visible sign of any change in the cross section area at the fracture location. Thus the failure of the blade can be considered as a macroscopically brittle fracture process.

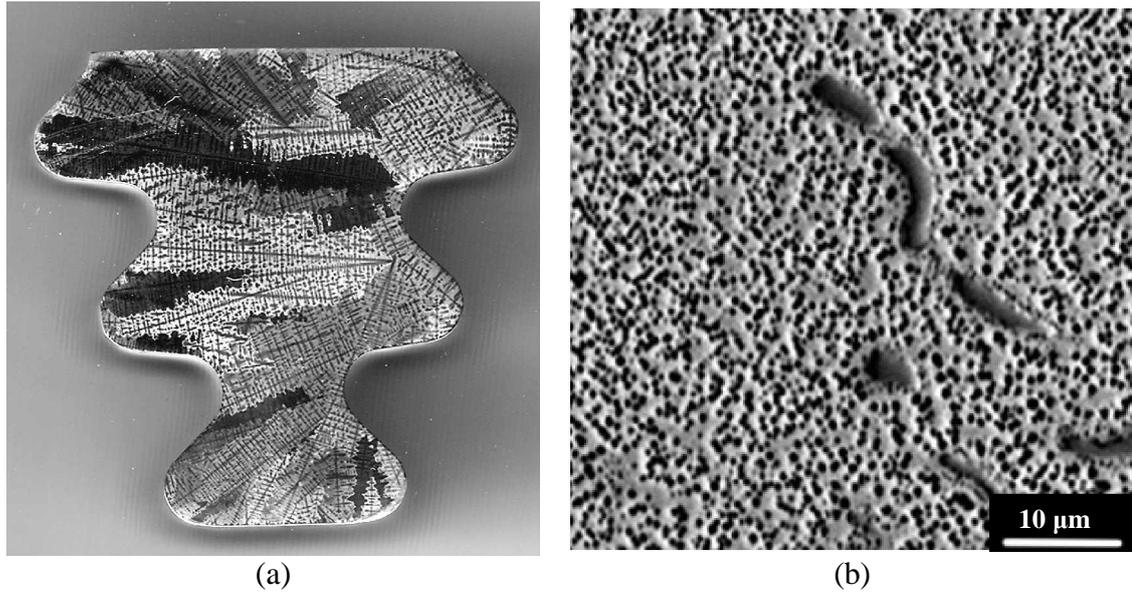
Metallographic observations were carried on transverse and longitudinal sections prepared from the firtree root region of the turbine blade beneath the fracture surface. A macroetched metallographic section of the firtree root showing the coarse dendritic structure of the cast Udimet 500 superalloy is presented in Figure 3(a). Distribution of fine gamma prime particles and interdendritic carbides in the matrix can be seen in a higher magnification SEM micrograph in Figure 3(b). The common strengthening mechanism of this alloy is precipitation hardening through gamma prime precipitation in the matrix. The gamma prime phase is an intermetallic compound of nominal composition $[\text{Ni}_3(\text{Al,Ti})]$ which is stable over a relatively narrow range of composition. The morphology of the gamma prime particles in the firtree root region does not seem to have been abnormally affected by the long term service of the turbine blade. The average hardness number of the blade material was found to be 32 HRC which was fairly uniform across the various metallographic sections.

Figure 3. (a) Macroetched section of the fir tree root, (b) SEM micrograph showing gamma prime particles and interdendritic carbides.

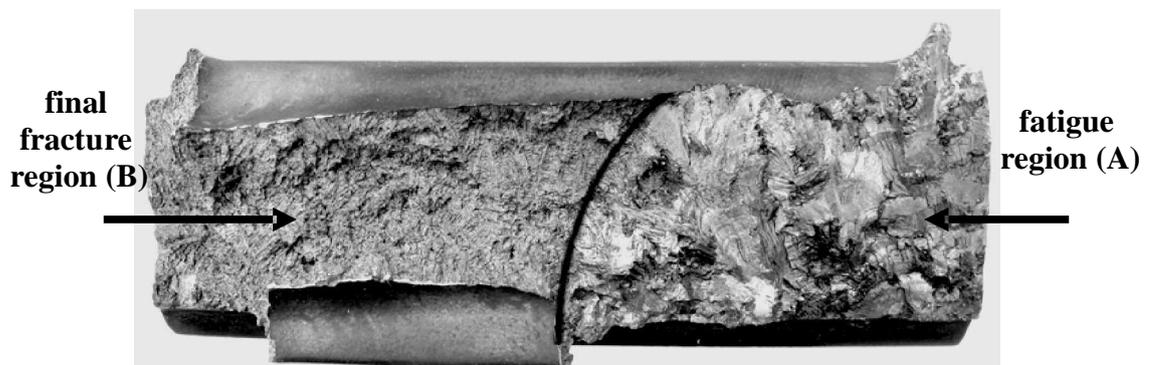
Macroscopic appearance of the fracture surface is shown in Figure 4. Two distinct regions denoted as A and B, which is delineated by a curved superposed boundary line, can be identified on the fracture surface. Region A has a more shiny appearance and extends from the boundary to the trailing edge side of the blade and covers about 40% of the fracture surface. Region B located in the opposite side extends up to the leading edge side of the blade. The fracture mechanisms in these regions are analyzed by SEM fractography.

Figure 4. Fracture surface of the blade.

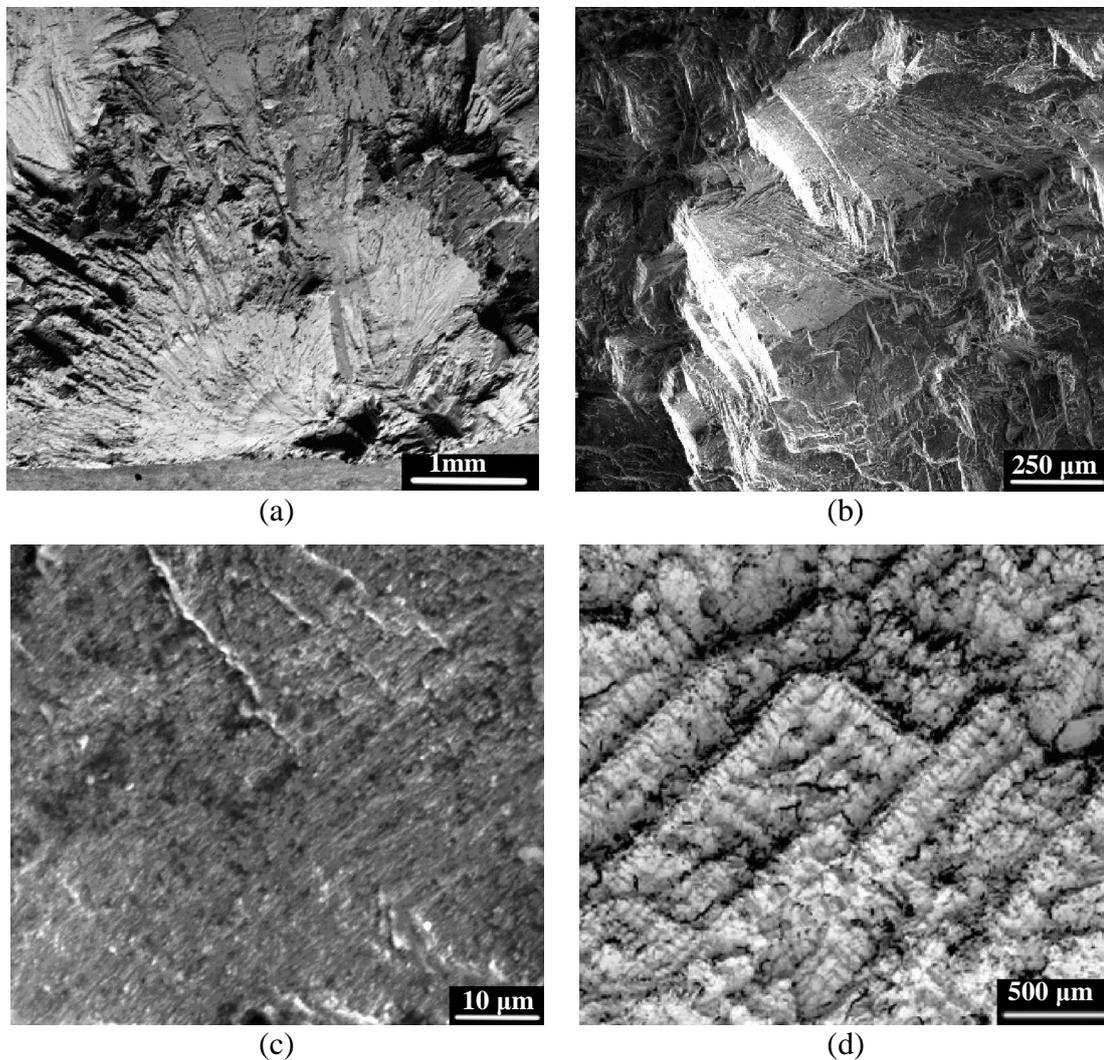
Following detailed SEM examinations of region A, a semielliptical crack region which originated at the top fir tree root was found as shown in Figure 5(a). Fine radial markings emanating from the crack nucleation zone can be seen in this fractograph. The fracture surface appearance in the early stages of crack growth near the initiation site is shown in Figure 5(b).

Faceted crystallographic crack growth characterizes the fracture surface morphology in this region. This type of crack growth has been previously reported for many planar slip and low stacking fault energy FCC alloys, including many of the nickel based superalloys, under cyclic crack growth conditions at relatively low stress intensity amplitudes [2]. Further examination of the fracture surface, in the middle parts of region A, reveals the formation of typical striation markings characteristic of progressive crack growth under high cycle fatigue conditions [8]. A fine band of dense striations can be seen in Figure 5(c). The fracture surface morphology in region B is indicative of a distinctly different type of fracture mechanism. The interdendritic and typically rough morphology of the fracture surface in this region is shown in Figure 5(d). This change in fracture surface morphology is associated with a transition from stable cyclic crack growth to unstable fast fracture due to the exhaustion of the load carrying capacity of the blade. From the fractographic point of view the change in fracture mode from transdendritic to interdendritic is considered as one of the typical features of fracture of cast materials by a fatigue mechanism.

Figure 5. SEM fractographs showing (a) semielliptical crack in the initiation region (b) crystallographic fatigue crack growth, (c) characteristic fatigue striations and (d) interdendritic fracture morphology in the final fracture region.

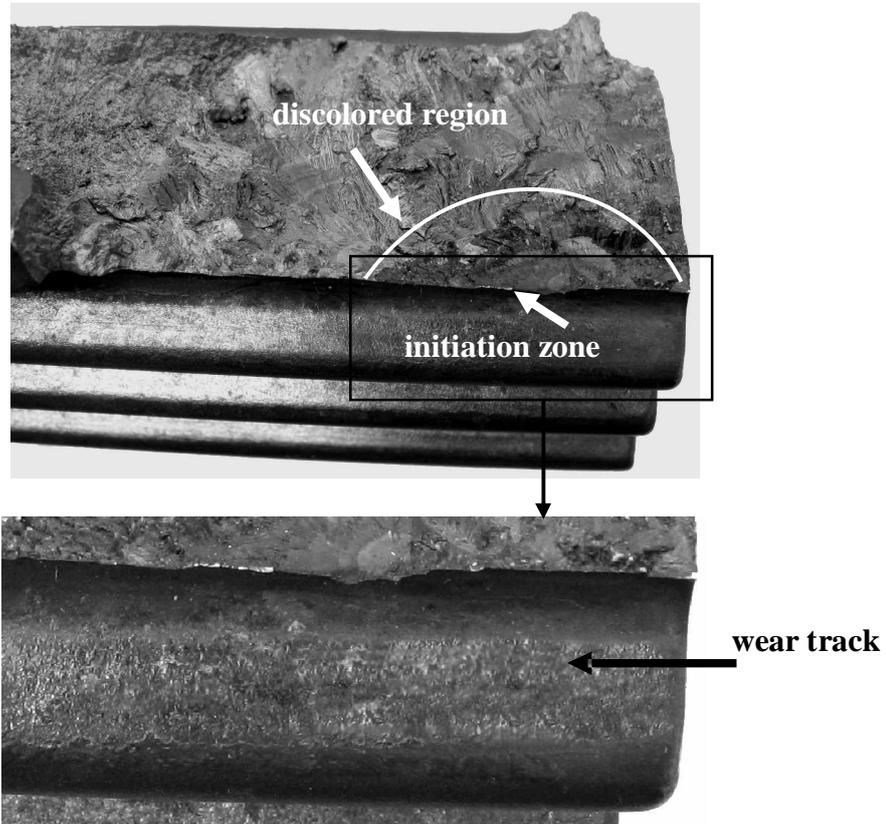
A magnified view of the fatigue fracture region of the turbine blade root failure surface is shown in Figure 6. The partially discolored region corresponds to the roughly thumb nail

shape crack extending from the crack initiation zone and is indicative of the exposure of the cracked blade to gas flow process. Close examination of the contact surfaces of the firtree joint reveals the formation of continuous tracks of about 3 mm wide across the entire contact surfaces (Figure 6). The magnified morphology of the tracks is shown in a SEM micrograph in Figure 7.

Figure 6. Magnified views of fatigue fracture region and a wear track .

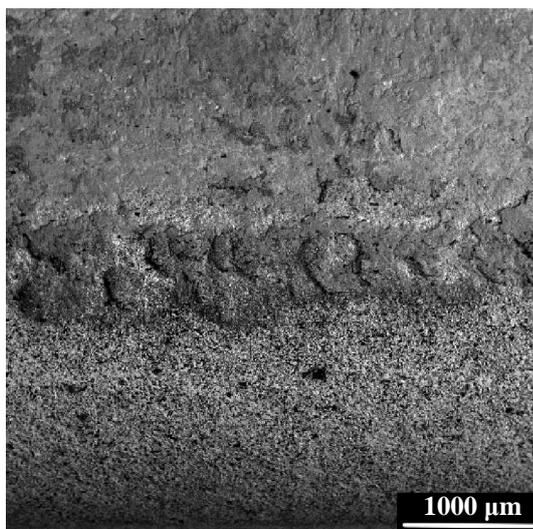
Figure 7. SEM micrograph of trapped debris forming a wear track.

The tracks seem to consist of accumulated wear debris particles trapped between the contact surfaces. EDS analysis of the wear debris shown in Figure 8 reveals a high concentration of iron, which is the base element in the chemical composition of the Cr-Mo-V steel disc material.

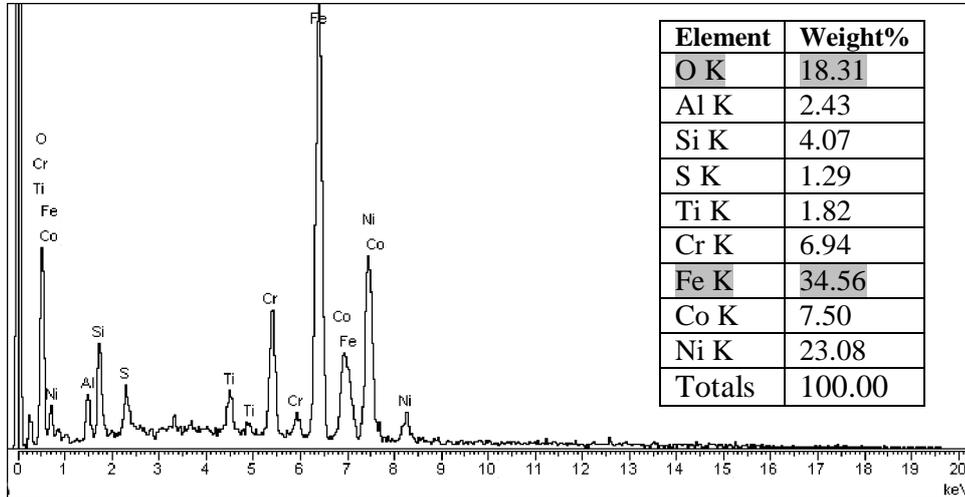
Figure 8. EDS analysis of wear debris particles on the wear tracks.

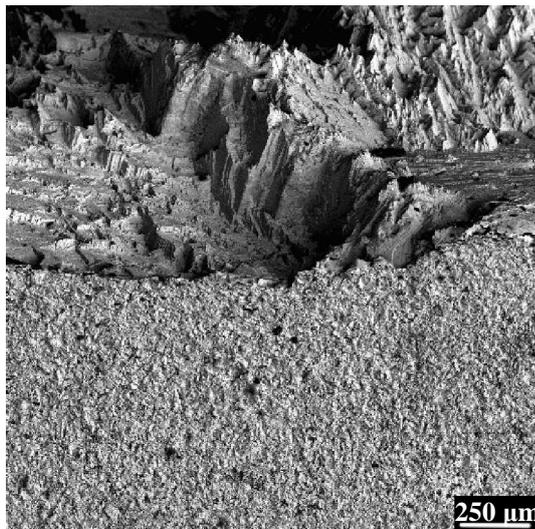
This entrapment of wear debris normally occurs under fretting wear conditions when opposing local surface regions in tightly held components undergo a small localized relative displacement for long periods. These conditions are typically encountered in the firtree roots of the rotating turbine blades. The firtree roots are also subjected to vibratory loads and high centrifugal forces leading to elevated contact and bulk stress, which combined with the relative displacements during operational cycles, compels them to endure fretting fatigue conditions. It can be seen from the magnified views of the crack initiation region and the wear tracks shown in Figure 6 that crack initiation region is located in close proximity of the wear track on the top firtree root. Furthermore the crack orientation in the initiation region is at an inclined angle with respect to the blade axis as shown in the SEM fractograph in Figure 9.

Figure 9. SEM micrograph showing slant crack orientation at the initiation region.

The above findings which include the formation of wear products on contact surfaces of fir tree root, presence of wear tracks, crack nucleation in the vicinity of wear tracks and the slant orientation of the crack in the nucleation region are indicative of the strong influence of the fretting fatigue mechanism [9,10] on the failure of the blade under investigation.
