FRACTOGRAPHIC INVESTIGATION OF FAILURES IN 316L STAINLESS STEEL ORTHOPEDIC CONDYLAR BLADE PLATE

**Fariba NAGHDI, Hassan FARHANGI, Maryam ZAHIRI AZAR
and Ali AMMARI ALLAHYARI**

School of Metallurgy and Materials Engineering, Faculty of Engineering,
University of Tehran, Tehran, Iran.

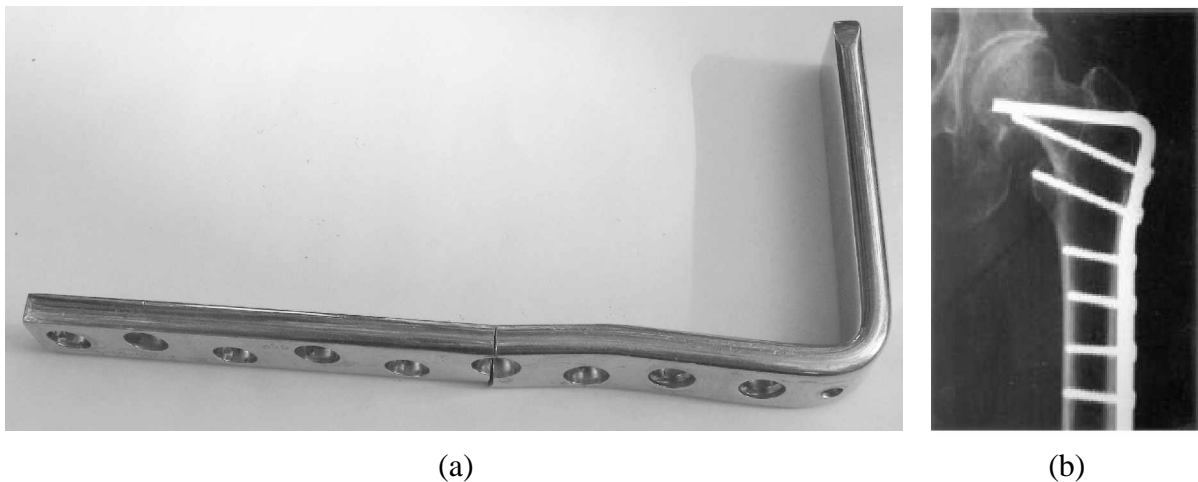
Figure 1. (a) Photograph of one of the failed condylar blade plates under investigation and (b) Radiographic image of the plate-screw-bone structure in the body [8].

It can be seen from the failed condylar blade plate shown in Figure 1 that the fracture location was at a section passing through a central hole on the plate where the cross sectional area is minimal. The general orientation of the fracture surface is roughly perpendicular to the long axis of the plate. Macroscopic appearance of the fractured condylar blade plate indicates that the fracture process occurred without any measurable change in cross sectional area or plastic deformation. Accordingly, the fracture process of the plates can be categorized as a macroscopically brittle fracture process [9,10]. Furthermore, visual examinations of the surface finish of the devices suggest the complete absence of corrosion contribution to the failure process. The fracture surfaces of the condylar blade plates under investigation are shown in Figure 3. The position of the fracture plane with respect to the central hole at fracture location can be clearly observed in this figure.

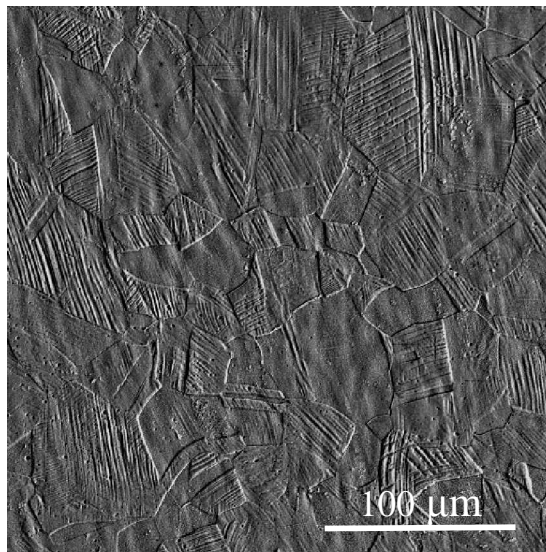
Representative SEM micrograph showing the microstructure of a failed condylar blade plate is shown in Figure 2. It can be seen that the microstructure exhibits a single phase matrix consisting of relatively coarse grains of austenite. Some slip lines and twins can be observed in some of the grains. The average hardness number of the condylar blade plates was found to be 310 VHN, which was fairly uniform across various metallographic sections.

Figure 2. SEM micrograph showing the microstructure of a failed condylar blade plate.

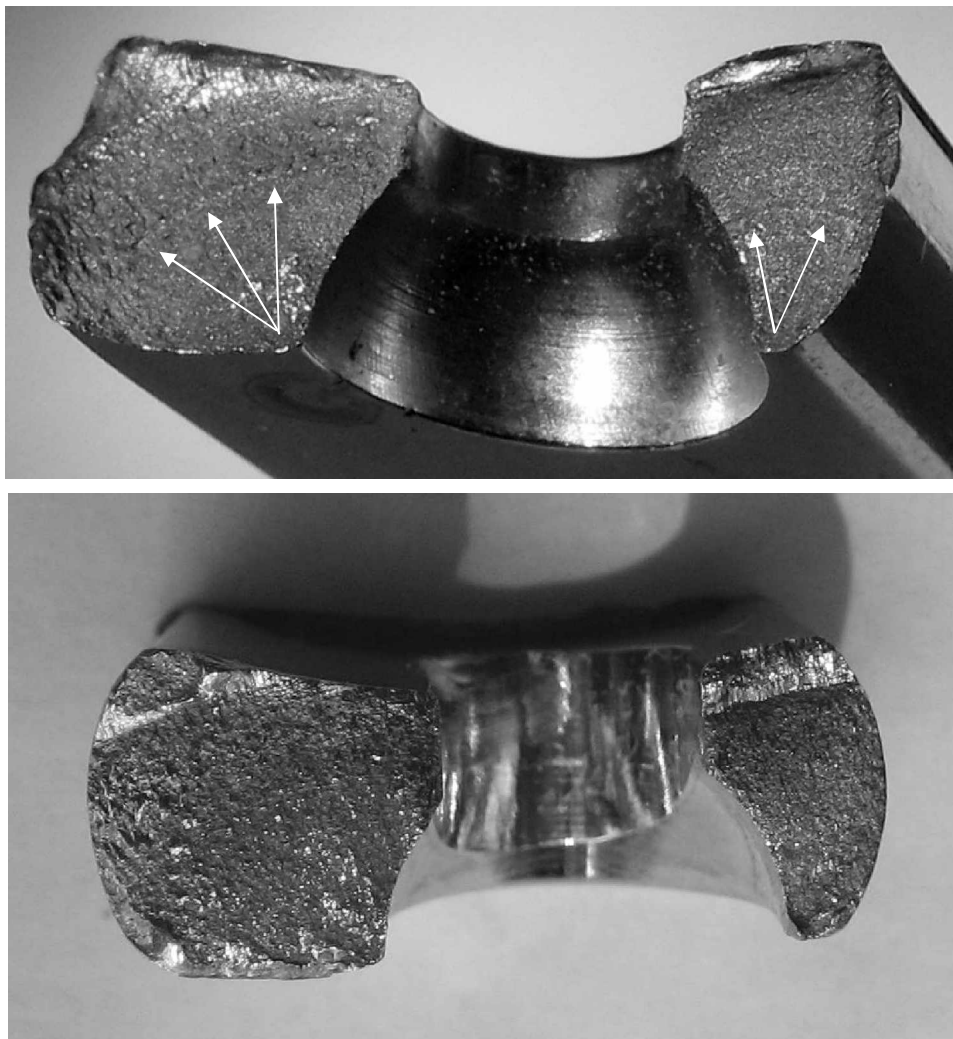
Figure 3. Fracture surfaces of the blade plates ($\times 7$).

Parallel and concentric bands of beach markings can be identified in localized regions near the middle part of the fracture surfaces as shown in Figure 3. Presence of beach markings in the macroscopic scale is indicative of the progressive nature of crack growth under variable amplitude fatigue loading conditions, with each marking delineating the position of the crack front at different stress amplitude [10].

Considering the orientation of the curved beach markings, crack initiation region can be traced back to the relatively sharp edged corners at the surface of designed central holes on the condylar blade plates, as shown by the superposed arrows in Figure 3. These regions acted as stress concentration sites on the reduced cross sectional area caused by the presence of central holes. A low magnification SEM fractograph showing the fracture surface of one of the blade plates is presented in Figure 4.

Initiation of voids in the dimpled fast fracture regions was facilitated by the presence of nonmetallic inclusions. Clear Shear lips formed at the ends of the final fracture regions can be seen on the fracture surfaces shown in Figure 3.

- 4- The fast fracture region exhibited a dimpled morphology indicative of final failure by ductile rupture mechanism.
- 5- Since prior to sufficient healing of the bone, the loads are primarily transferred through the support plates; proper post-operative immobilization can be effective in preventing the application of cyclic loads and avoiding fatigue failure of condylar blade plate implants.

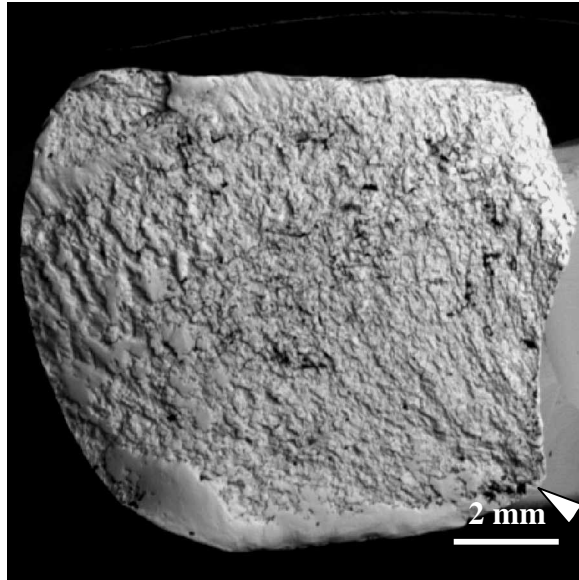
Figure 4. SEM fractograph showing the fracture surface. The arrow points to the crack initiation region.

Radial lines originating from the crack initiation region in the general macroscopic crack growth direction and some faint beach markings can be identified on the fracture surface. The crack initiation region is shown at higher magnification in Figure 5.

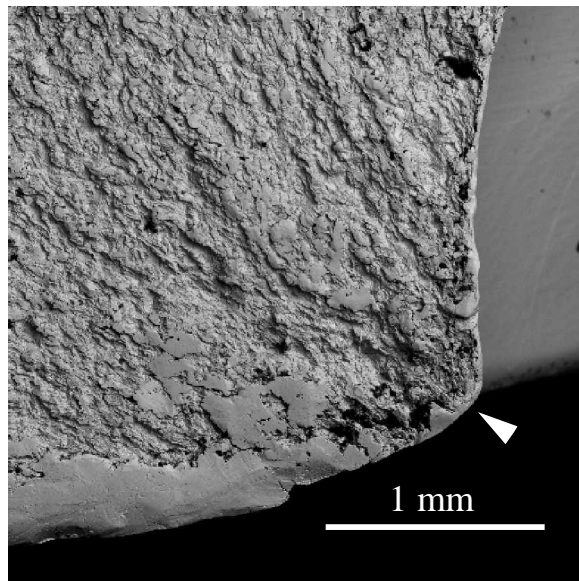
Figure 5. Higher magnification SEM fractograph of the crack initiation region at the corner of a central hole on the condylar blade plate.

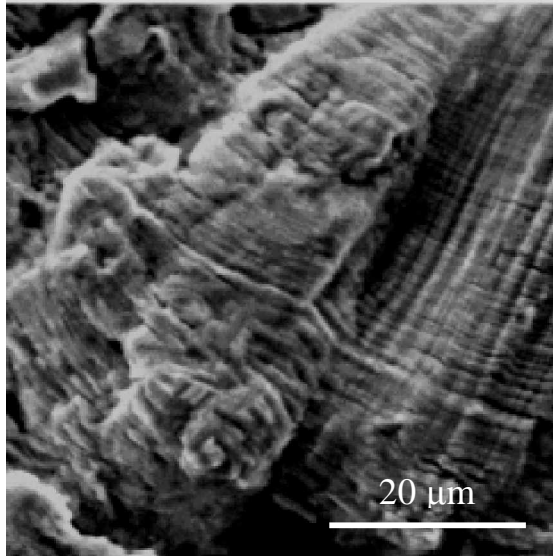
Figure 6. SEM fractograph showing typical striations on the fatigue fracture surface.

Striations, which show the position of crack front during successive loading cycles, are considered as the main microscopic sign of failure by fatigue fracture process [9,10]. Subcritical stable fatigue crack growth by striation formation continued until the onset of final fracture. The fast fracture region exhibits a dimpled morphology (Figure 7) characteristic of failure by ductile rupture mechanism [10].

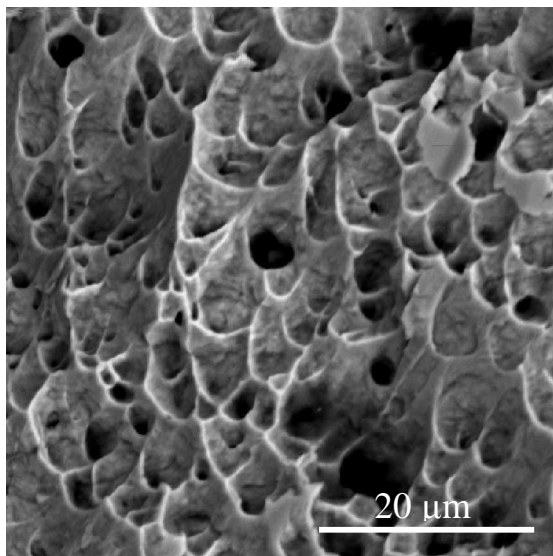
Figure 7. SEM micrograph of dimples formed in association with nonmetallic inclusions in the final fracture region of the condylar blade plate.
